Client: 9999HO Sample HOA

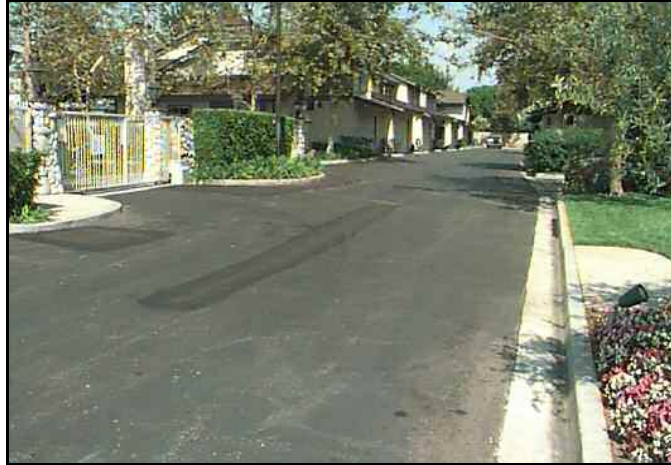
**Comp #:** 201 Asphalt - Resurface

Evaluation: Observed to be in good to fair condition. Signs of cracking found in various areas. Very extended life if periodically sealed and repaired, but expect eventual resurface to be necessary.

Useful Life:  
20 years

Remaining Life:  
5 years

Lower estimate for resurface project, \$1.25/GSF

Higher estimate, includes more repair work, \$1.75/GSF

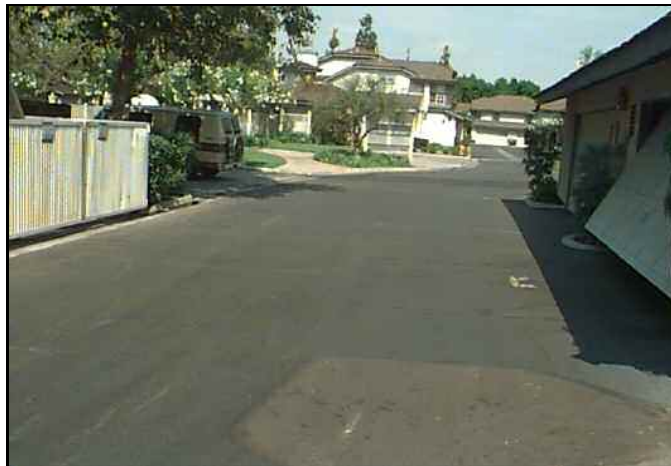
**Comp #:** 202 Asphalt - Seal/Repair

Evaluation: Observed to be in fair to poor condition. Signs of dryness and loss of seal evident. Seal coat has been scheduled after our site inspection and before end of Fiscal Year, so assume almost new condition for this coming Fiscal Year.

Useful Life:  
5 years

Remaining Life:  
4 years

\$0.15/GSF, estimate for to clean, seal, and stripe.

\$0.20/GSF, Higher estimate, includes additional local repair expenses.

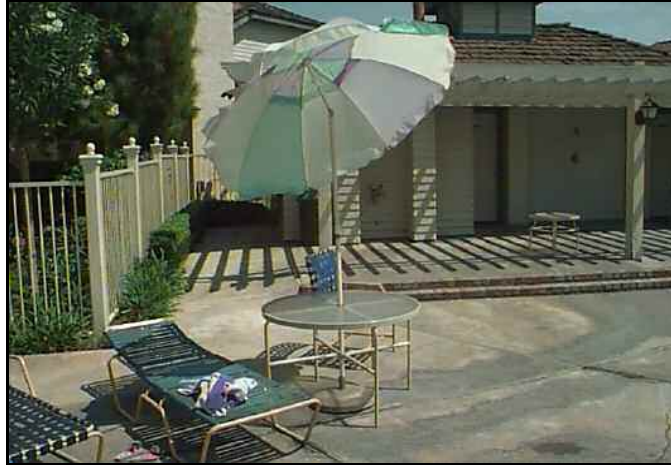
**Comp #:** 404 **Patio Furniture - Replace**

Evaluation: Some strap fading and paint chipping from frames. Missing straps on chairs, and tears on the umbrellas were apparent. Time to replace this asset.

Useful Life:  
6 years

Remaining Life:  
0 years

Estimate for replacement, avg of \$175 each piece

Higher estimate for better quality replacement, avg of \$250/each.

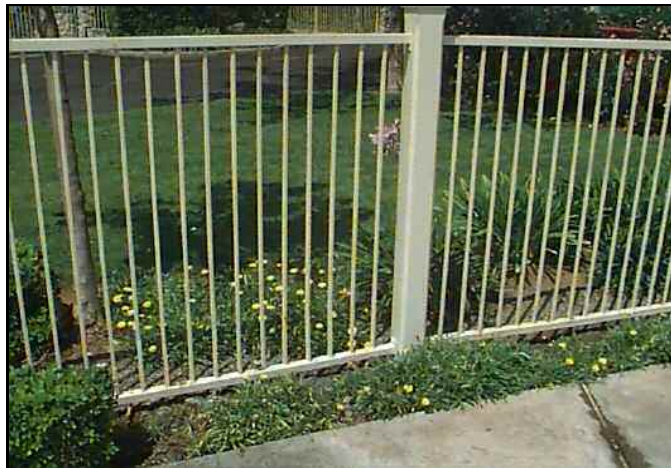
**Comp #:** 503 **Iron Fence - Replace**

Evaluation: Minor signs of rusting and corrosion noted at base of structure. Expect local repairs, but no expectation for total replacement if painted and maintained on an ongoing basis.

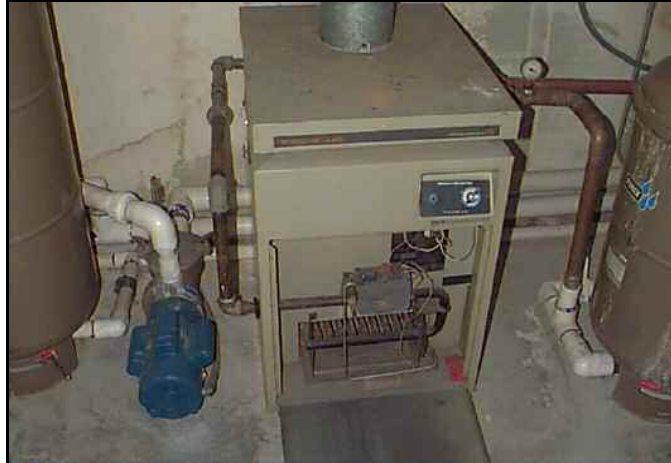
**Comp #: 1208 Spa Heater - Replace**

Evaluation: Appears to be in good working order. Moderate rusting/scaling of burners. Housing is still clean. Igniter assembly appears to have been replaced. No evidence of fire damage inside.

Useful Life:  
10 years

Remaining Life:  
2 years

Lower estimate for replacement heater, installed

Higher estimate.

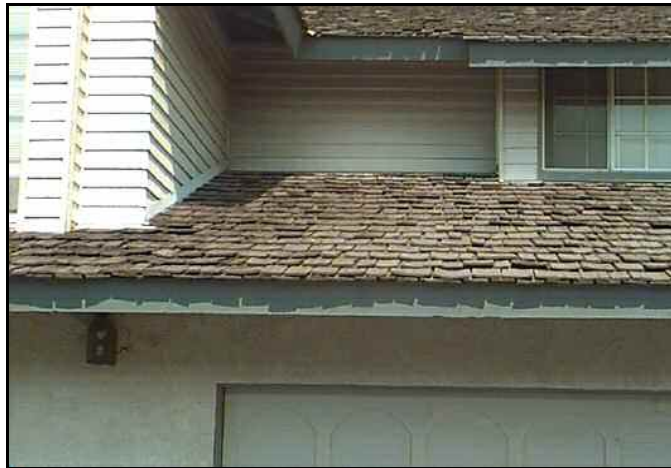
**Comp #: 1305 Wood Shingle Roof - Replace**

Evaluation: Good condition. No warping or dislocation of wood shingles noted. No reports of leaking through roofs.

Useful Life:  
25 years

Remaining Life:  
13 years

\$6.00/GSF, lower estimate for replacement.

\$7.50/GSF, Higher labor or material cost estimates
